New Studies in the Archaeology of Jerusalem and its Region

Excavations at Saint John Prodromos, Jerusalem

Jean-Baptiste Humbert
École Biblique

Technical report for floors and underground of the crypta

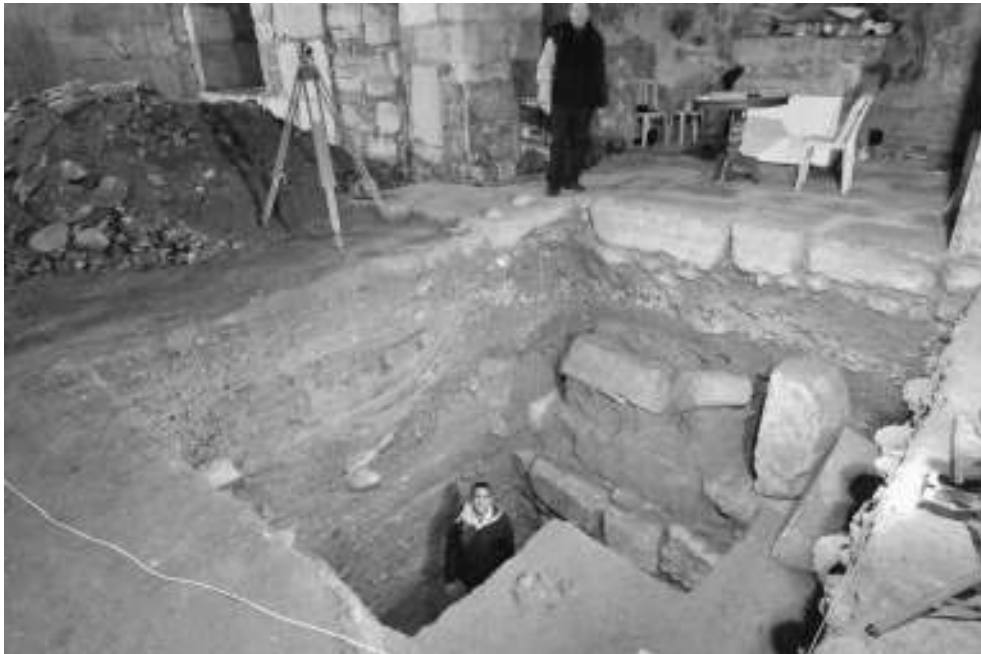
1a Undisturbed stratification in sounding A

a – principal survey “a” in the center of the main hall (Figs. 1a-b)

We have established the following stratifications:

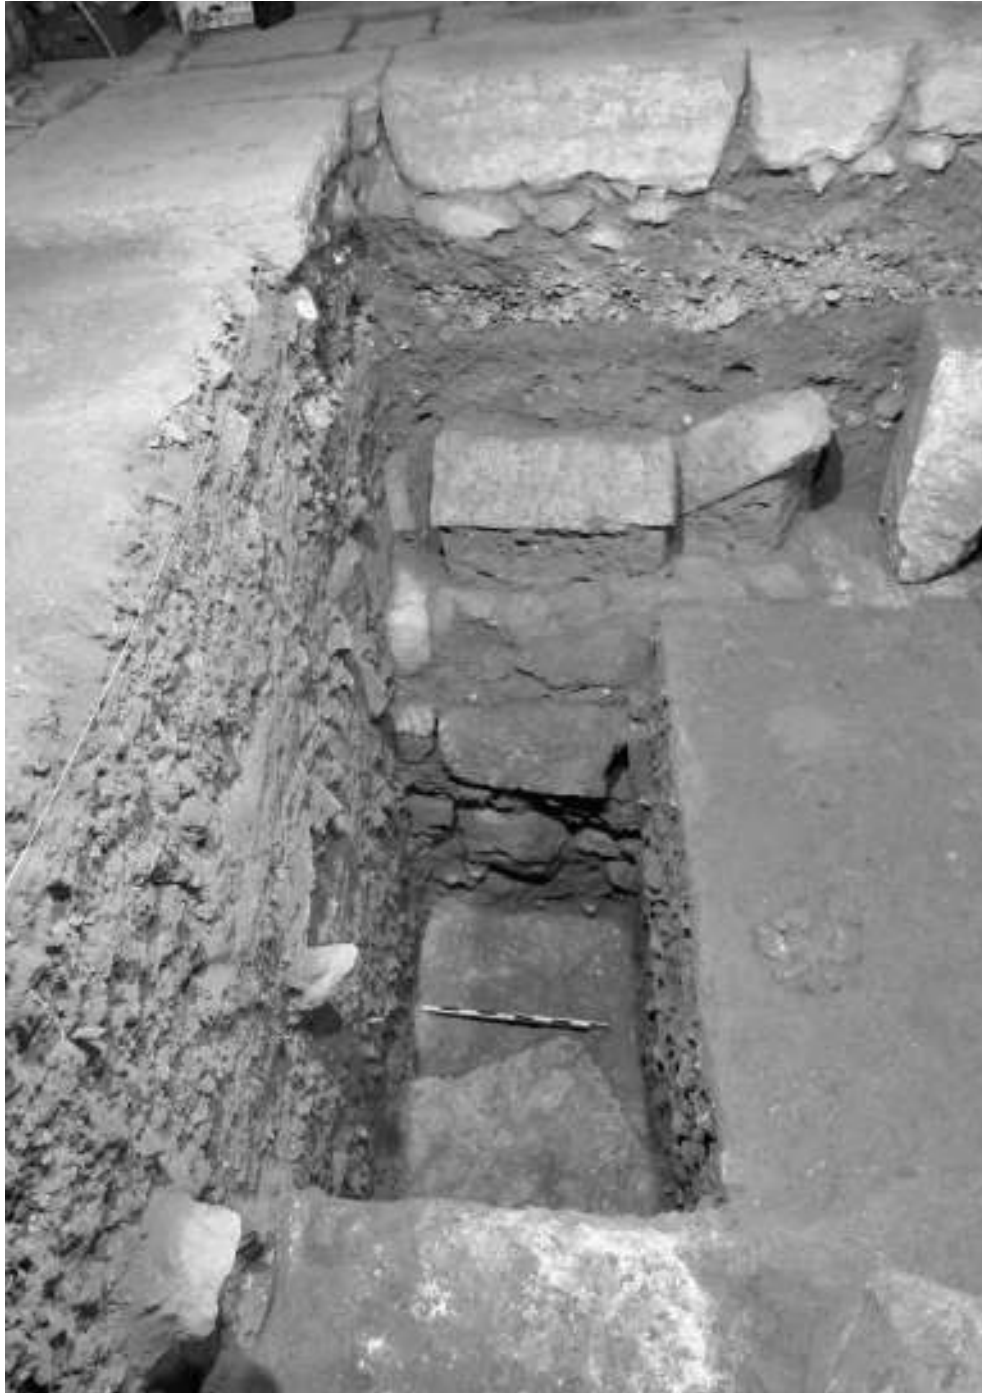
1b Undisturbed stratification in sounding A

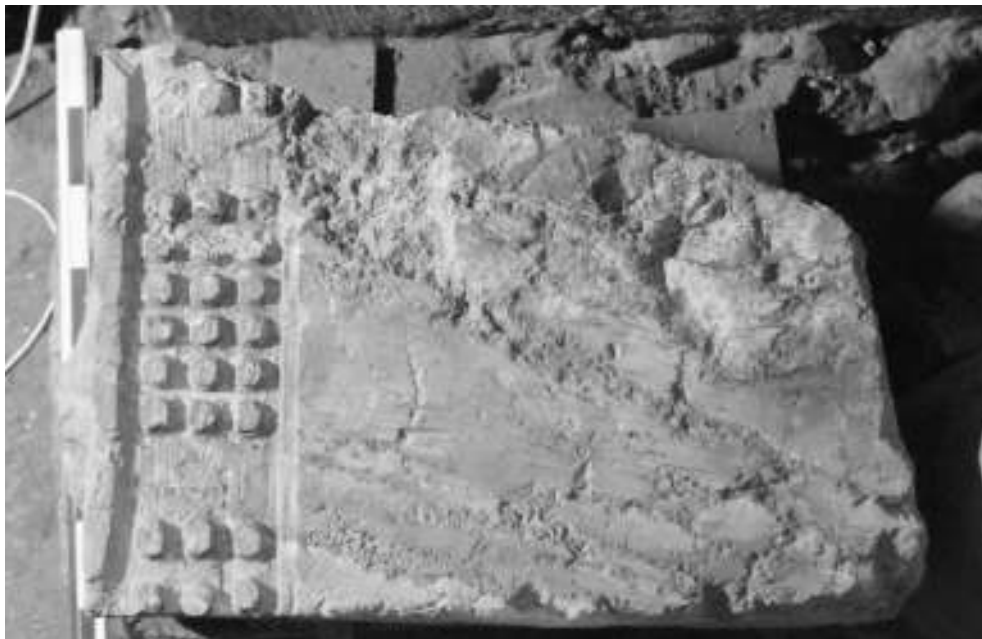
2 Entablature fragment from the foundation A7

these finds alongside the high-quality ashlar remains, in addition to the decorated segment of entablature, there is a high likelihood of our having excavated a refuse-area dating to Herod's Jerusalem. We have two options in terms of dating the fill: i) the clearing-away of debris of Herod's ruined city in the period preceding AD70; or ii) the period following the destruction of Jerusalem by Titus (post AD70).

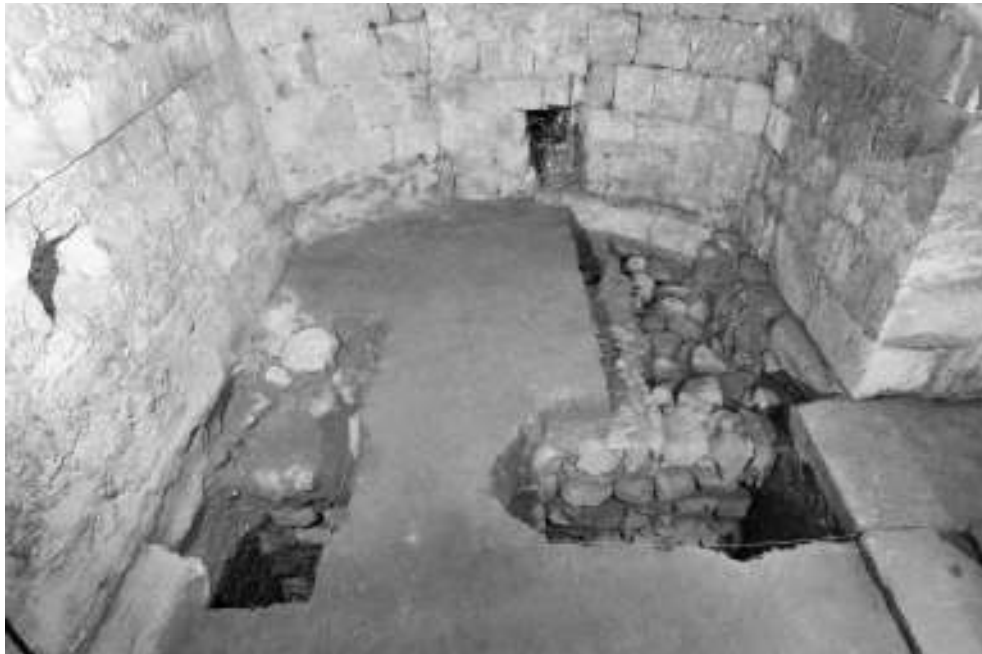
3 The platform foundation of the south exedra

B-C 5 – A massive platform occupies the entire surface of the Southern exedra (Figs. 3-4). Its exposed Northern face is in precise alignment with the two antes of the exedra. The platform is clearly the solid foundation of the Southern wing of the Roman building. While the Northern face of the platform is more or less vertical, its frontage is devoid of regularity: it is the crudely-built wall of a terrace. Subsequent soundings confirmed that the wall functions to delimit the platform, and that the platform consists of a mass of large stones, carelessly thrown

The platform, which extends over the entire surface area of the apses, drops down over two meters in depth below the ground course of the exedra, and in alignment with the antes. We were not able to verify that the platform also supports the Southern face of the building, although this seems likely. The platform may even extend beyond the building's exterior alignment. Only the North face of the platform is exposed, from which can be seen the irregularities of the foundation. The bulk of the platform is an accumulation of large unsquared blocks. Its summit is leveled with a bed of uncut stones or quarry splinters, covered with a dark grey ash mortar. The ash mortar is sealed, in its turn, by a fine coating of lime-plaster with

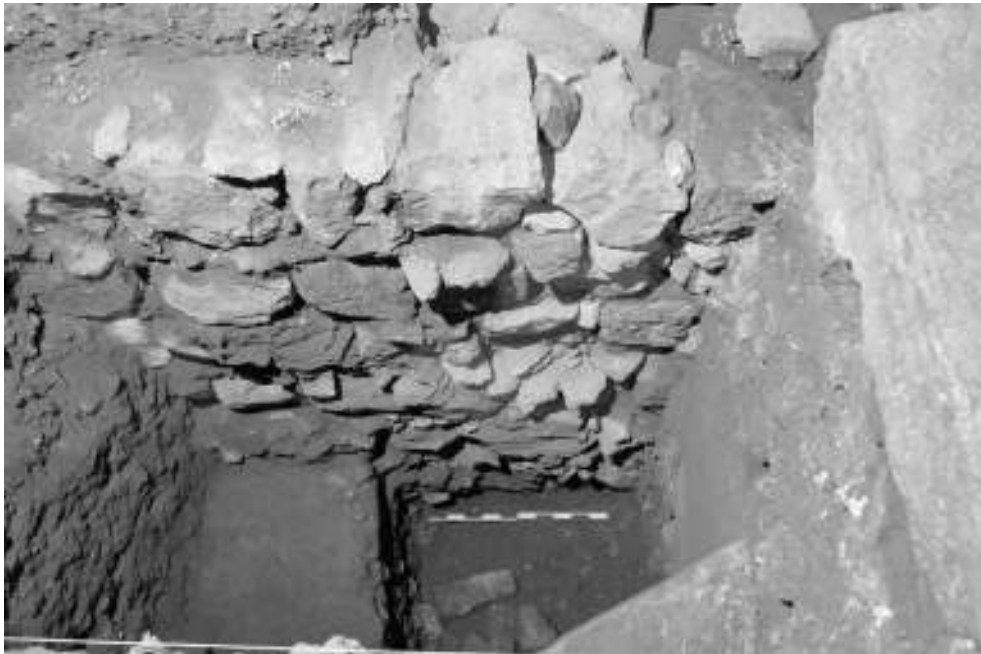
4 Sounding B, northern face of the platform

construction does not change. A section of what is assumed to be the late Iron Age rampart, at this particular location, moreover does not sit well in terms of potential city layouts that might logistically relate this site to the Citadel in the South-West, where Iron Age remnants have been found. We noted earlier that chalk blocks and quarry splinters of the same material punctuate the surface area of the platform; like soundings A8 and A9, these chalk elements are products of the dismantling of the Herodian level. The platform necessarily postdates this destruction event. Erratic traces of the Iron Age have been identified at the base of the platform. It has however been verified that the thin Iron Age layer underlies the platform and is not associated with it.

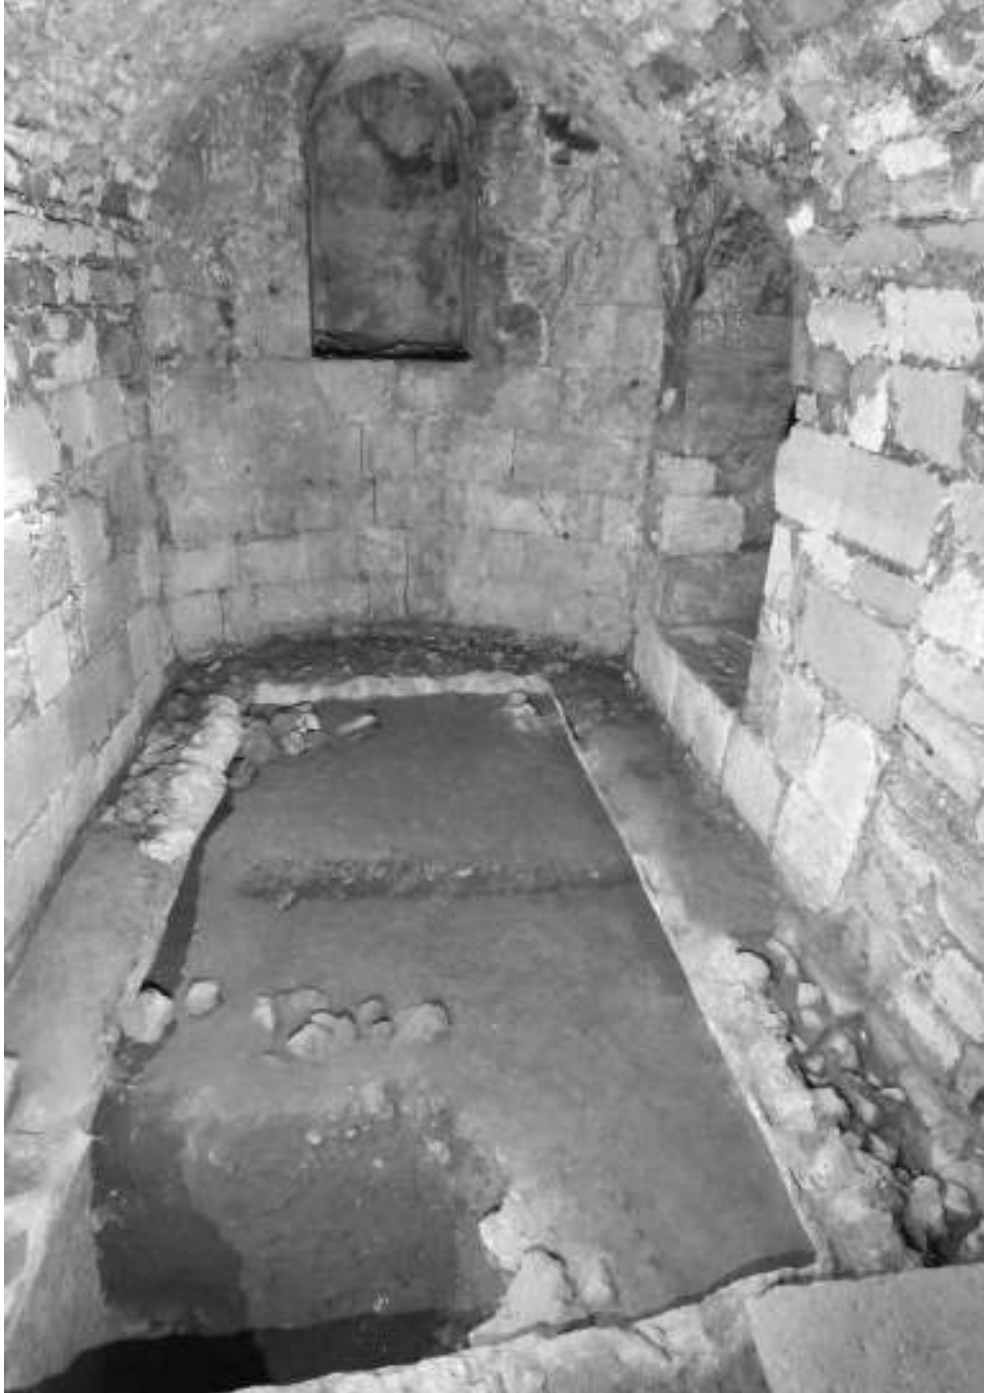
5 General view of northern nave with the medieval cistern

E 2 - The cistern occupies the entire surface of the Northern nave and descends 3m underground. Its installment probably necessitated the complete removal of underlying layers of archaeological sediment. The cistern is contemporaneous with the Medieval upper church. The actual point of entry, in the North-East corner, was accessed via the street, and consisted of a passage with ascending steps. The steps did not lead to the floor of the crypt; they led to the top (then intact) of the cistern vault which at that time would have been at the level of the well. The protruding vault of the cistern was later clipped-off and its body filled to restore, to the crypt, a floor that was level from North to South. The fill of the cistern yielded a quantity of imported glazed pottery from the Mamluk period. We assume that the architectural restructuring of the underground crypt corresponds to its conversion, by the Greeks in the 15th century, into a chapel.

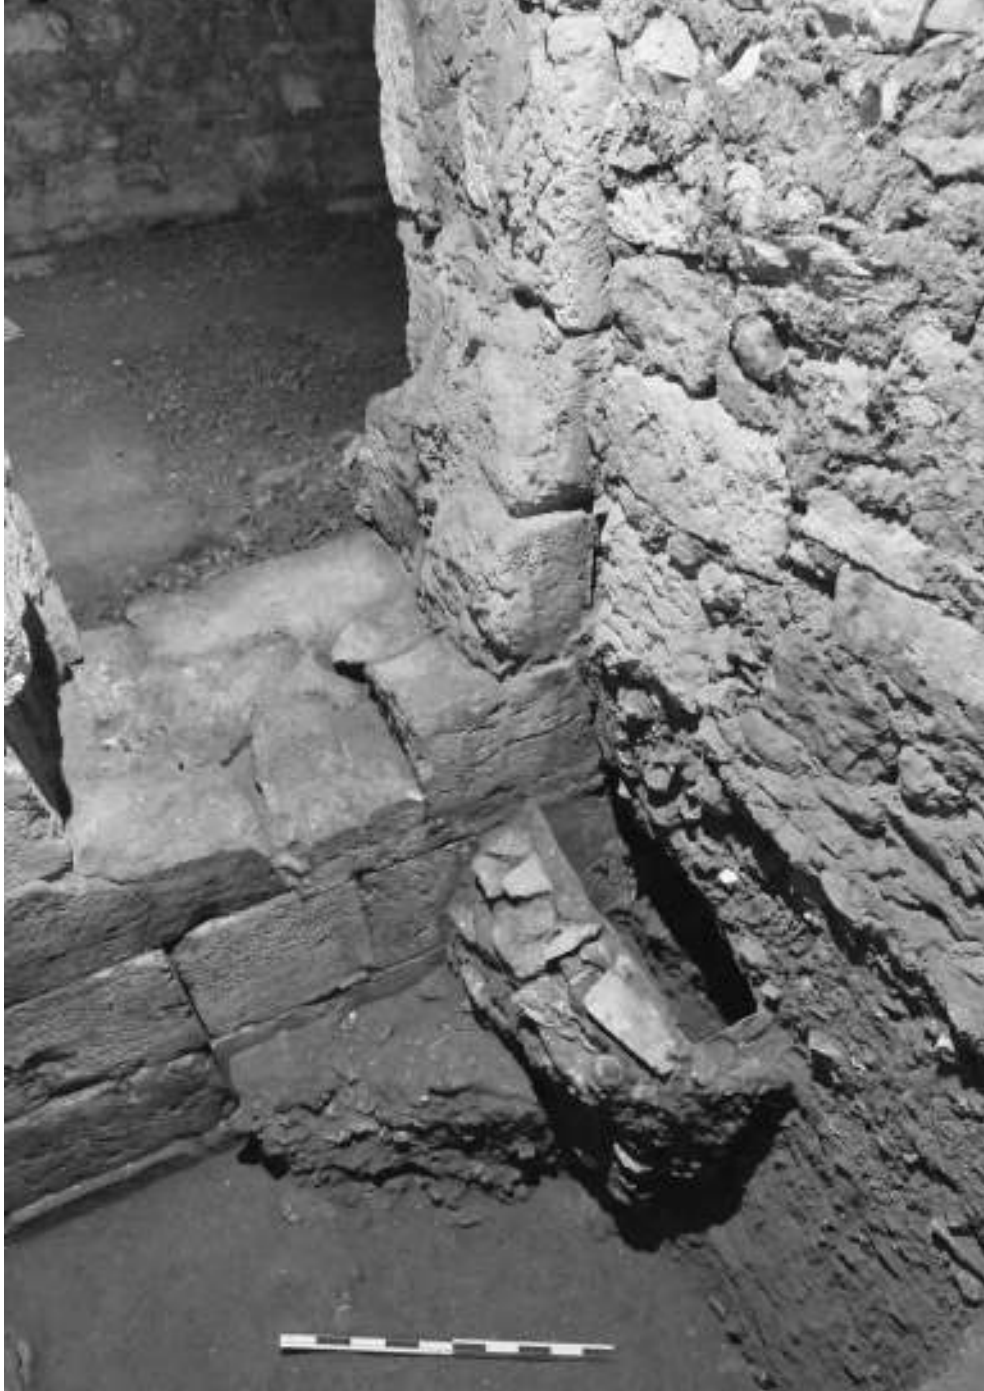
6 Sounding F - Umayyad/Abbasid period (close up)

F – The soundings F, G, H, J in the broad back room: the corridor (Fig 6)

Four soundings were implemented in the Southern half of the corridor : F, G, H, J. The objective of the soundings was to document the foundations of the Eastern and Western walls of the corridor. Soundings F, G, H, that were implemented against the Eastern wall, exhibit identical stratigraphic sequences reaching all the way to the bedrock, between 2.90 and 3.20m in depth. The bedrock underlying the trefoil hall reached greater depth, approximately 4 m. Nothing indicates, however, that a natural slope inclines downward to the East since bedrock exhibits traces of a quarry of late Iron Age exploitation, one which is old enough to have been in use extra muros. It would be interesting to compare it with the iron age quarry recently uncovered by Sholmit Weksler-Bdolach in Western Wall's plaza excavations. The Roman building was settled over a rock cut stage, lying below another rock cut stage to the West, namely the site of the pool of Hezekiah (or the Pool of the Patriarch's Bath) whose occupation of the site dates back to Antiquity. Its eastern dyke, which flows downstream, is in alignment with the sharp rise separating the two stages. The foundations of the wall between the corridor and the main hall are, at every point, installed on bedrock. The large chalk blocks in the foundation courses are clearly a re-use; they have, as their point of origin, the shadow architecture of A9. The chalk blocks were somewhat clumsily stacked one over the other

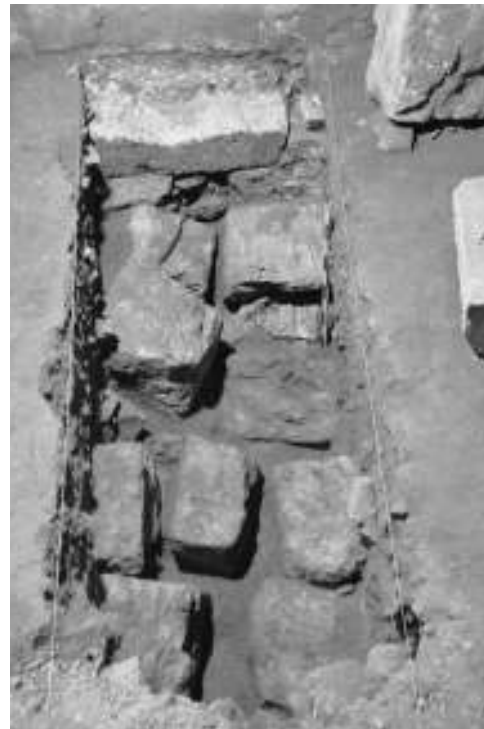
7 The fallen disposition of the western wall of level A7 sounding K

K – Investigation, in the main hall, of the foundation of the separation wall (orientation East) between the main hall and the corridor (Fig 7)

The threshold sits on a foundation less than 1m in depth. The builders encountered an heap of fallen blocks which they judged to be reasonably solid. These blocks are arranged in a manner reminiscent of a collapse, such as that of masonry. They are cut from chalk material to the standard of the A 9 blocks and are in association with the tile fragments of the aggregate that seals the stylobate. We propose that they be considered as the collapse of the North-South wall of the construction at A 7 (Hadrian in date).

The odd empty space under the threshold might be the result of a water-based process of erosion dating back to a period when the building was abandoned without its roof. Precipitation runoff
